**JUDAY CREEK
FEASIBILITY STUDY**

ST. JOSEPH COUNTY, INDIANA

March 2002

J.F. New & Associates, Inc.
708 Roosevelt Road
Walkerton, IN 46574
(574)-586-3400

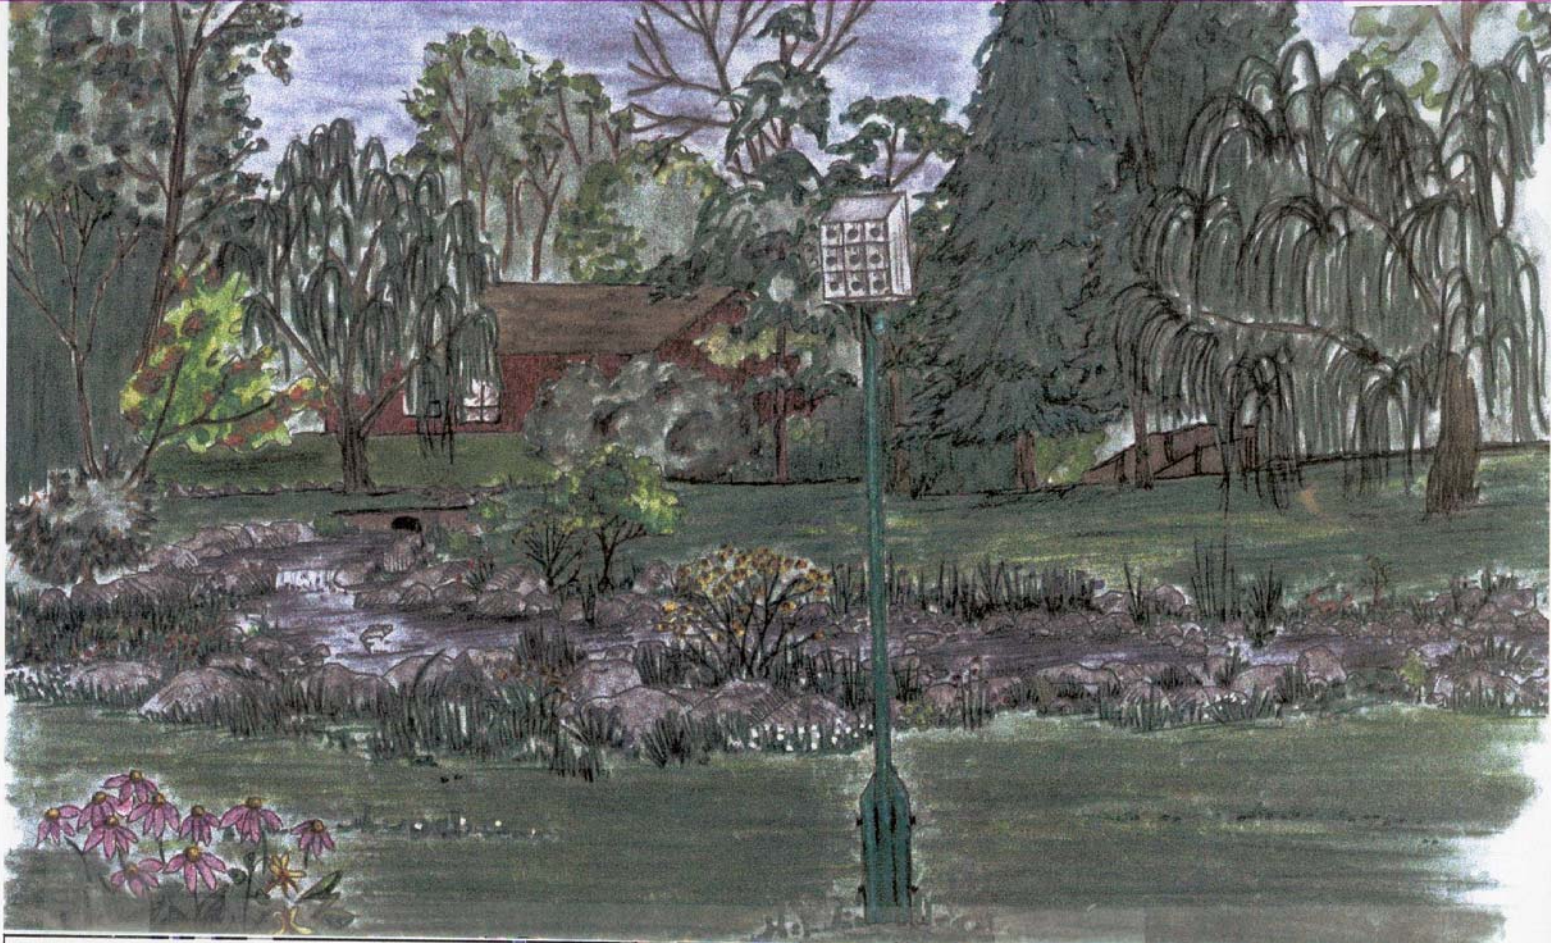
FIGURE 12: Pond Fill/Constructed Stream Channel Rendering
Judy Creek Feasibility Study

PROJECT: Pond Fill/Constructed Stream Channel (Douglas Road East of Ironwood Road)
St. Joseph County, Indiana

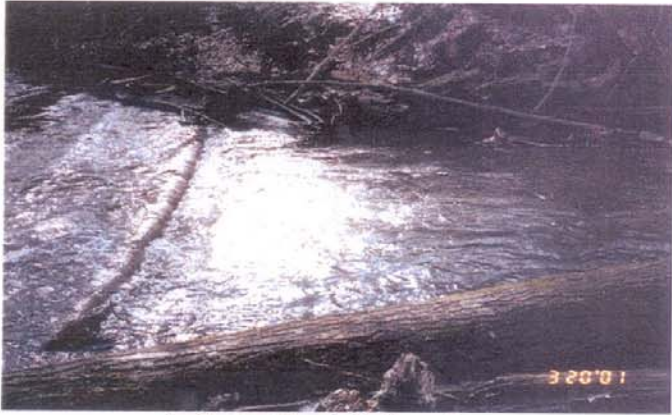
A: Stream Reach 7, Cross Log

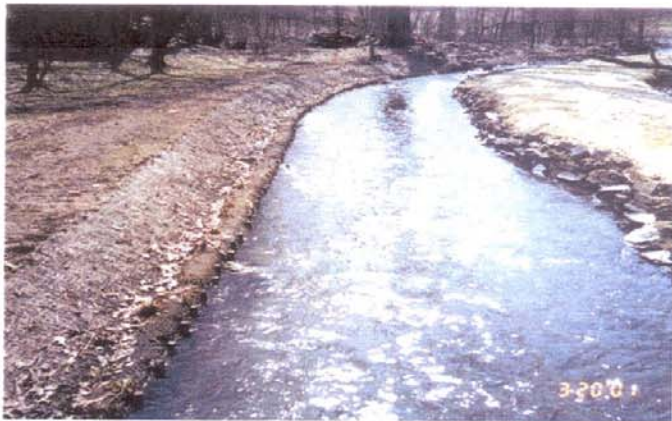
B: Site 21, Stream Reach 7, Biolog/Rock Installation

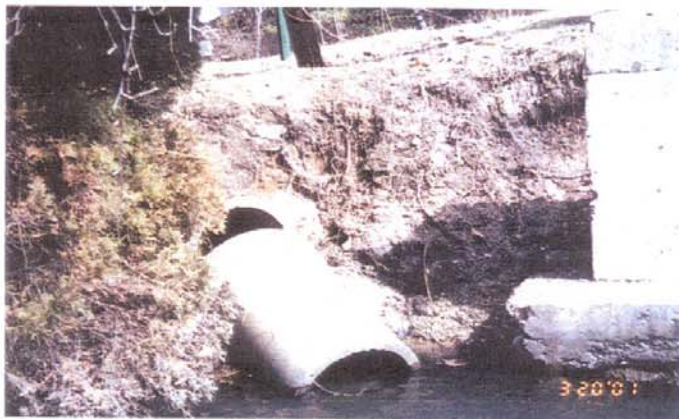
C: West Side of Kenilworth Road

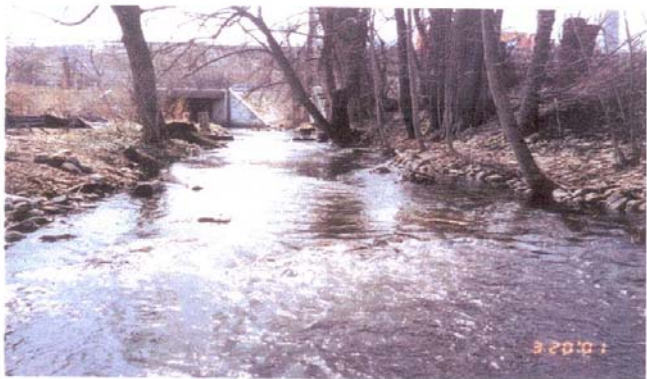
A: Site 1, Stream Reach 7, In-stream Habitat Improvements

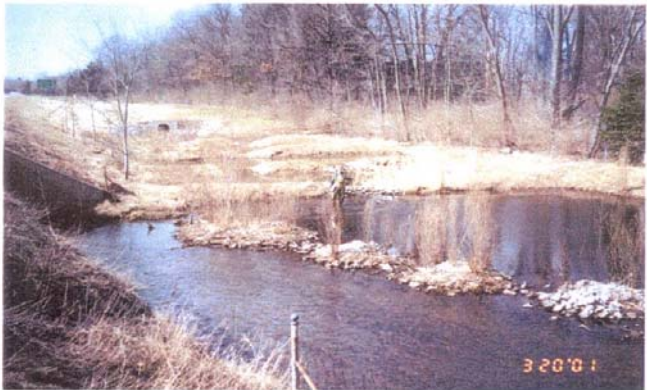
B: Site 2, Stormwater Filter

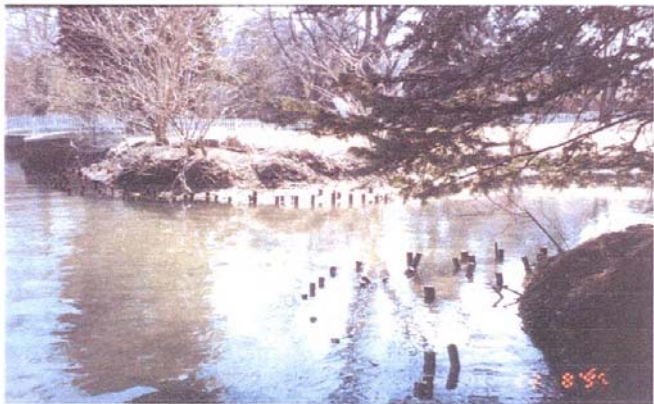
C: Site 29, Biolog Erosion

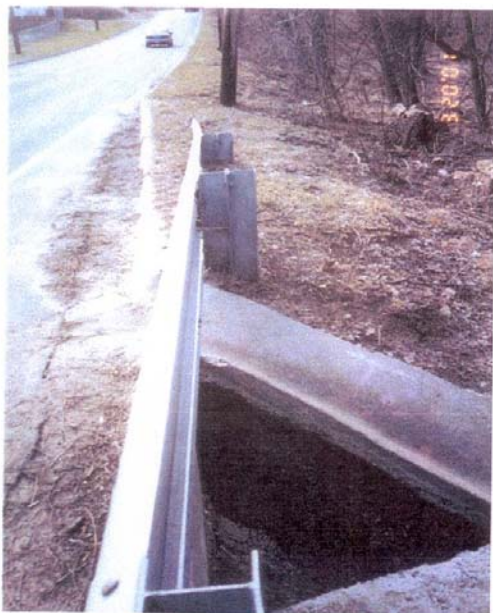
A: Erosion on Douglas Road Bridge

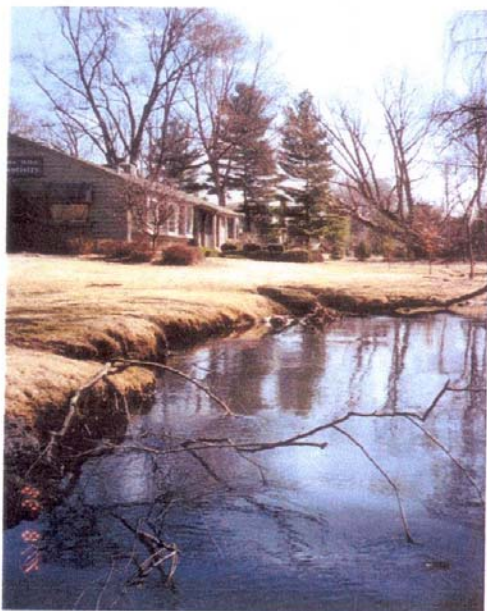
B: Lunker Structures at Site 37

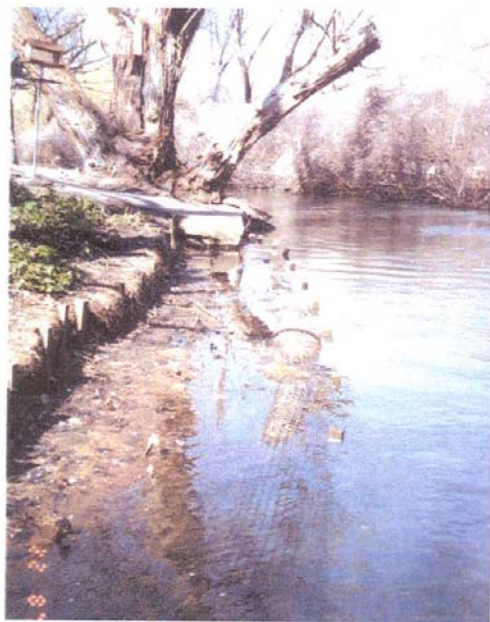
C: Installation of Biologs at Site 36

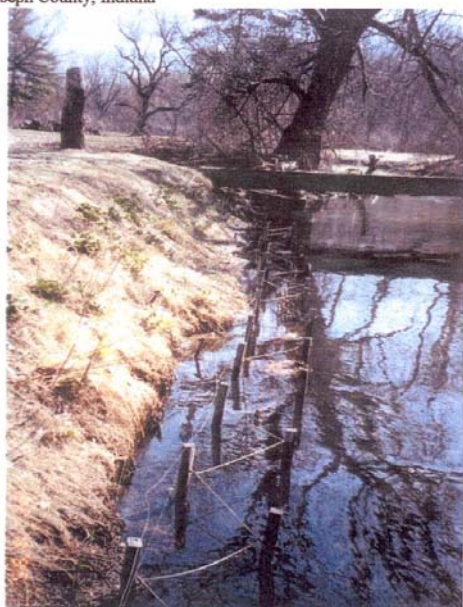
A: Eroded Biolog Installation

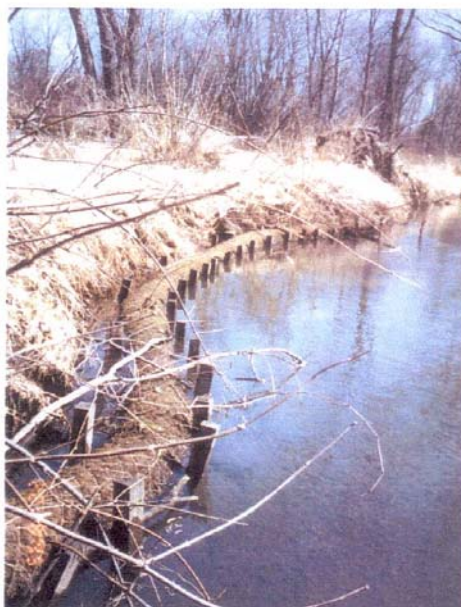
B: Biolog Installation

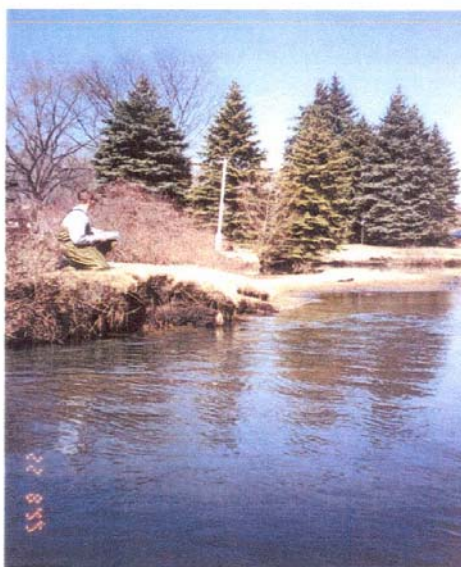
C: Severe Bank Erosion Around Streamside Pond

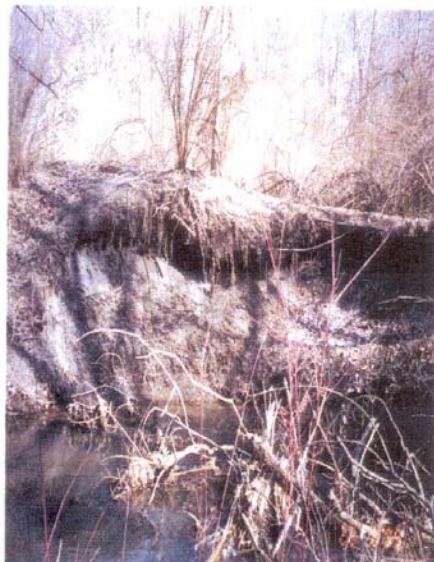
B: Bank Erosion Near Fir Road

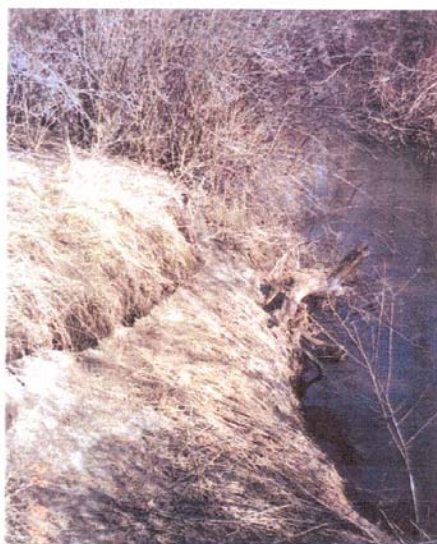
C: Erosion Near Fir Road

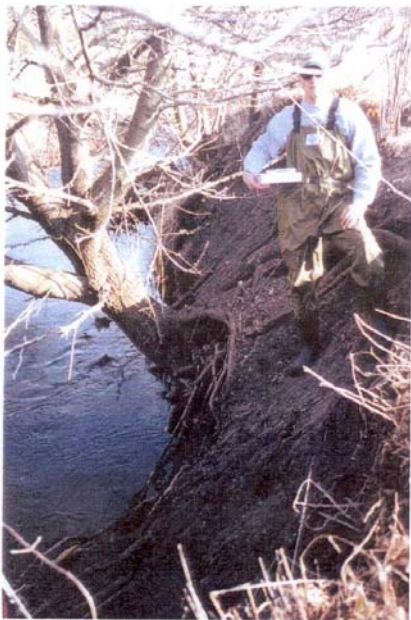
A: Steep Eroded Banks

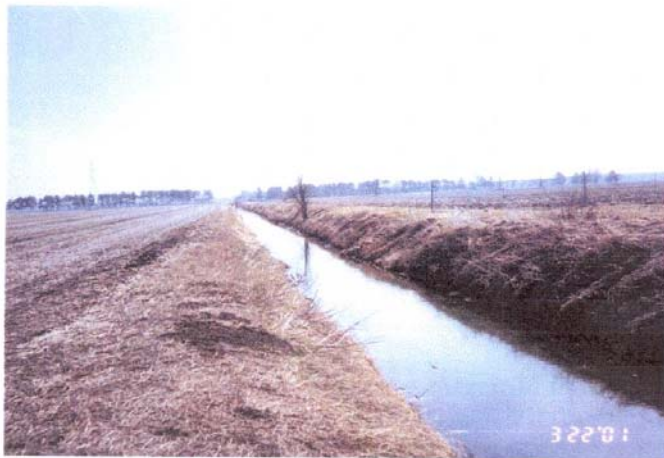
C: Channelized Nature of Stream Reach 1

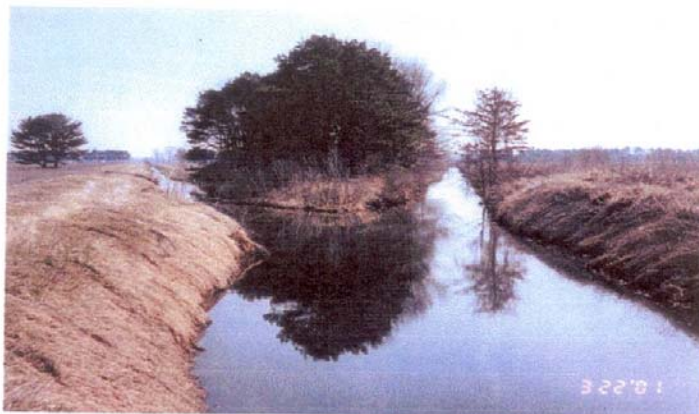
A: Scamborn Ditch Entering Juday Creek in Reach 1

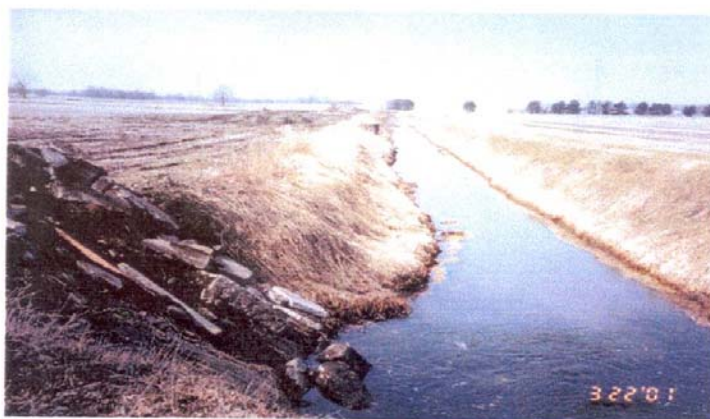
B: Dumping of Material into Juday Creek

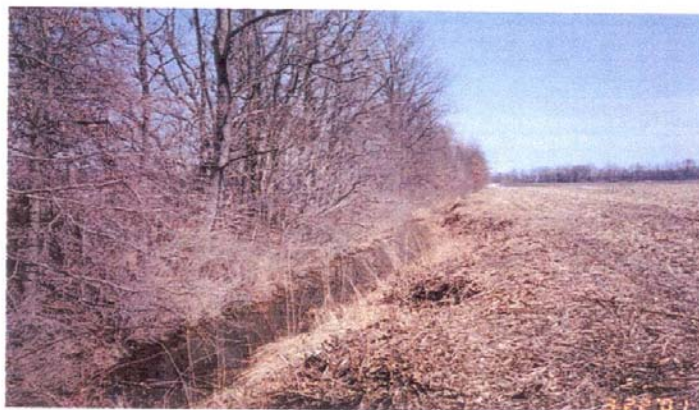
C: Ditch North of Interstate 80/90

A 1,000-foot drainage ditch parallels the north side of Interstate 80/90 in Granger, Indiana, just east of Juday Creek (Figure 1). This ditch has steep slopes (1:1) and is severely eroding due to the sandy soils and limited vegetation. Runoff from the Toll Road and periodic high flows in the ditch has caused most of the observed erosion. Regrading and stabilizing ditch slopes are the primary components of this proposed project.
